Zion Crossroads
Small Area Study

TECH MEMO
EXISTING AND FUTURE NO-BUILD CONDITIONS
JULY 2020

Figure 1: Study Extents - Zion Crossroads Study (Louisa and Fluvanna County)

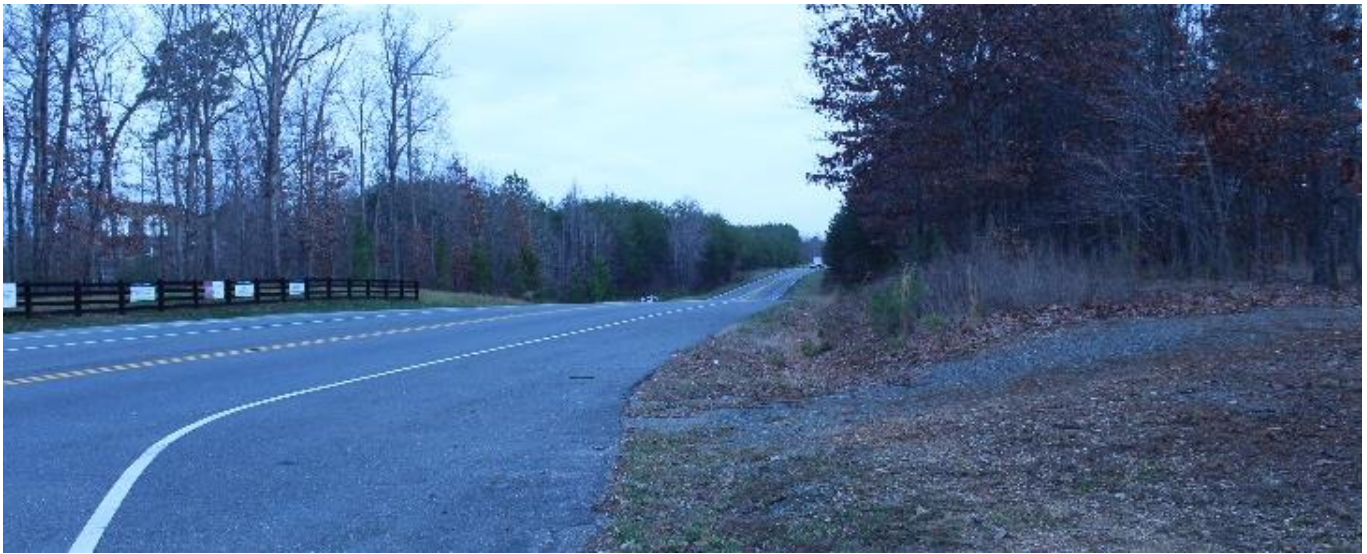
expectations along this section. The vertical profile of this segment is generally rolling hill terrain – adding to motorists’ difficulty to gauge other drivers’ behaviors. This is shown in Figure 4 at the intersection of US 15 and Spring Creek Parkway/Stonegate Drive. Trucks from the Walmart Distribution Center tend to enter and exit this area at the intersection of US 15 and Liberty Trail, resulting in a more concentrated area of mixed passenger vehicle and truck traffic.

Figure 4 Westbound Approach on Spring Creek Parkway looking north along US 15 (Intersection #2)

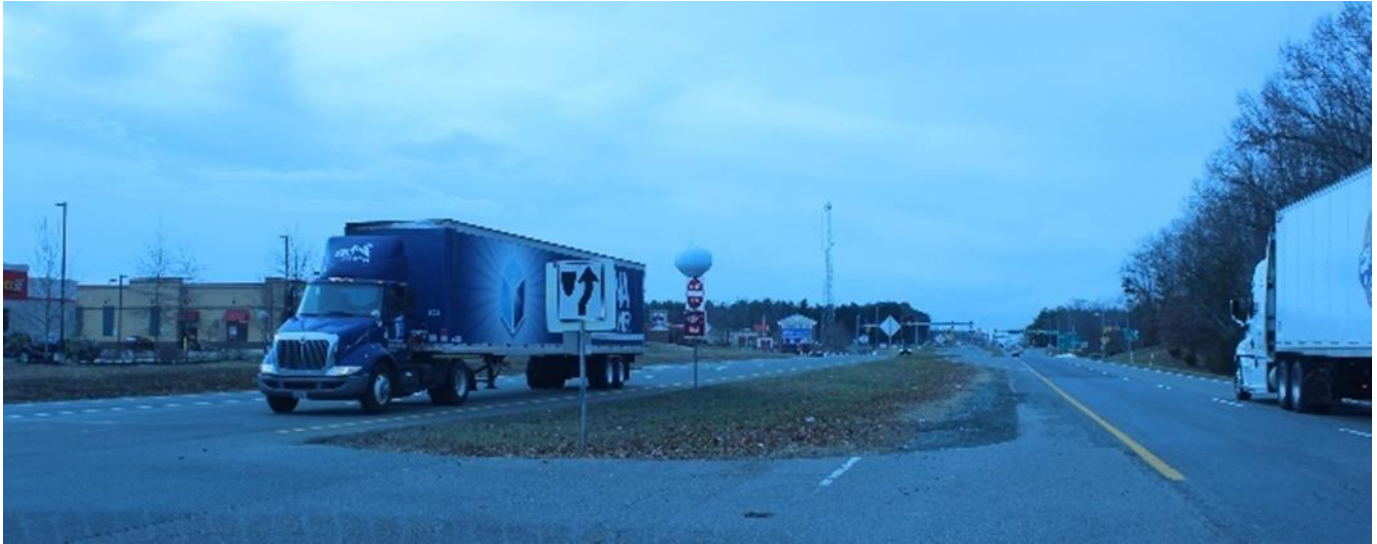
two-lane facility to four-lanes with a median. Turn lanes are also present to support access into the new restaurants and businesses. This section also serves much of the heavy vehicles traffic to/from the Walmart Distribution Center and other businesses at the Shoppes at Spring Creek, as shown in Figure 5.

Figure 5 Southbound US 15 at Freedom Drive (Intersection #5)

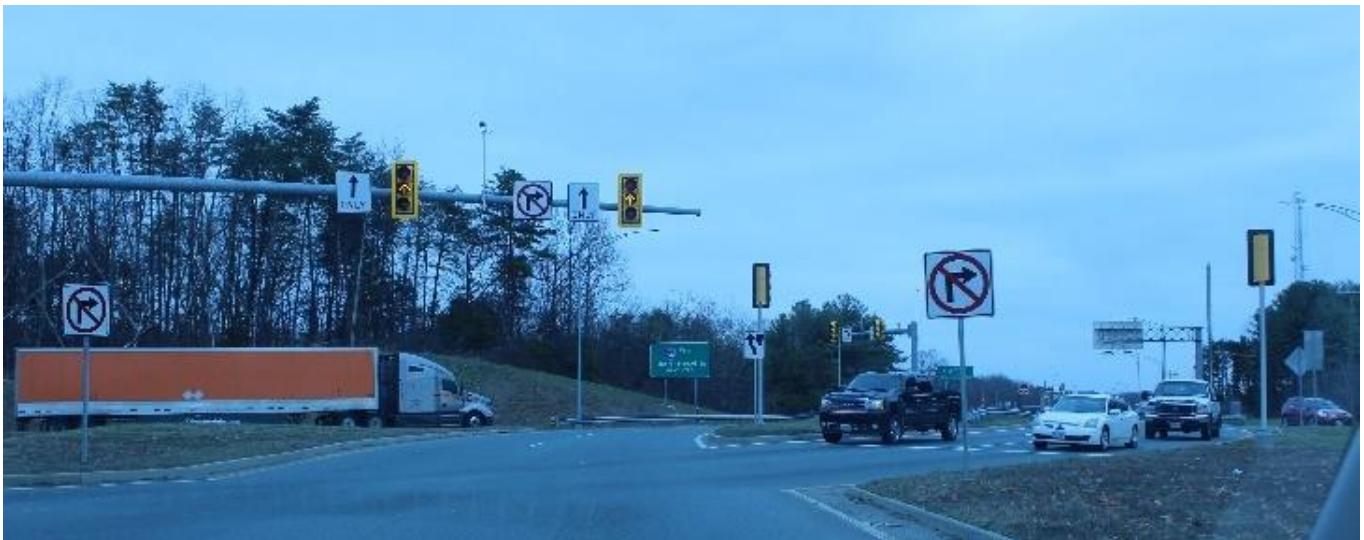
are provided on both I-64 and US 15. Traffic signal control is provided at the DDI crossovers and other major intersections, and within the DDI the speed limit is reduced from 45 MPH to 30 MPH along US 15. However, the Stakeholders have expressed that this reduction in speed is not always obeyed. This facility is shown in Figure 6.

Figure 6 Southbound US 15 at the North DDI Ramp Terminal (Intersection #9)

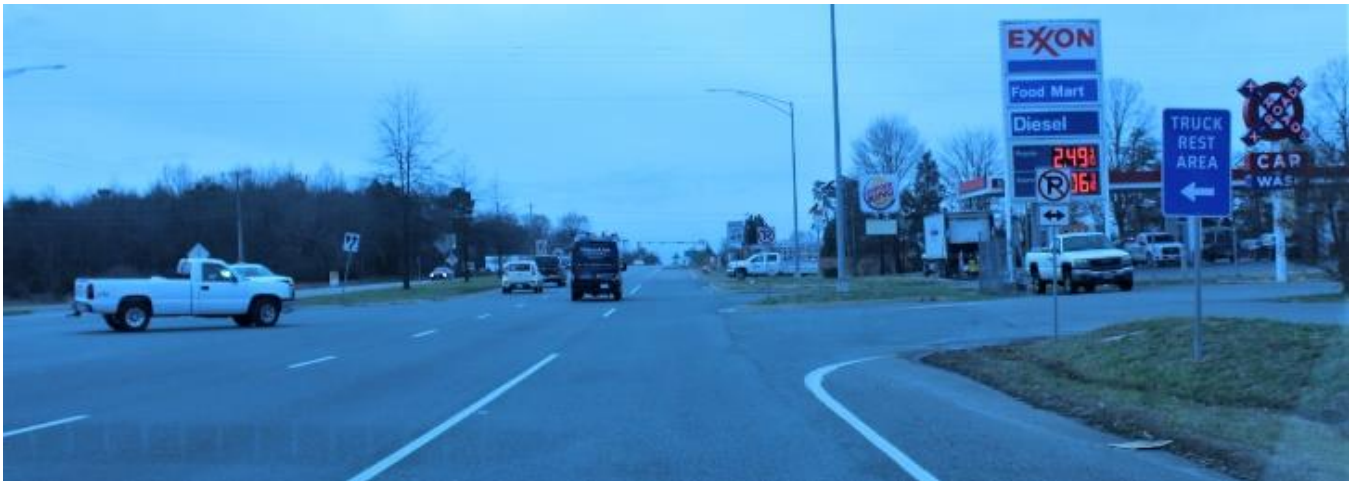
Through field visits and discussions with the Stakeholders, it is evident that drivers have difficulty finding gaps for turns to/from Crossing Pointe Drive and the multiple business driveways. In addition, there is a truck stop at this intersection and an additional truck stop proposed at the intersection of US 15/US 250 which leads to a high level of truck traffic on this segment. These conditions contribute to both operational and safety issues are shown in Figure 7.

Figure 7 Southbound US 15 at Crossing Pointe Drive (Intersection #11)

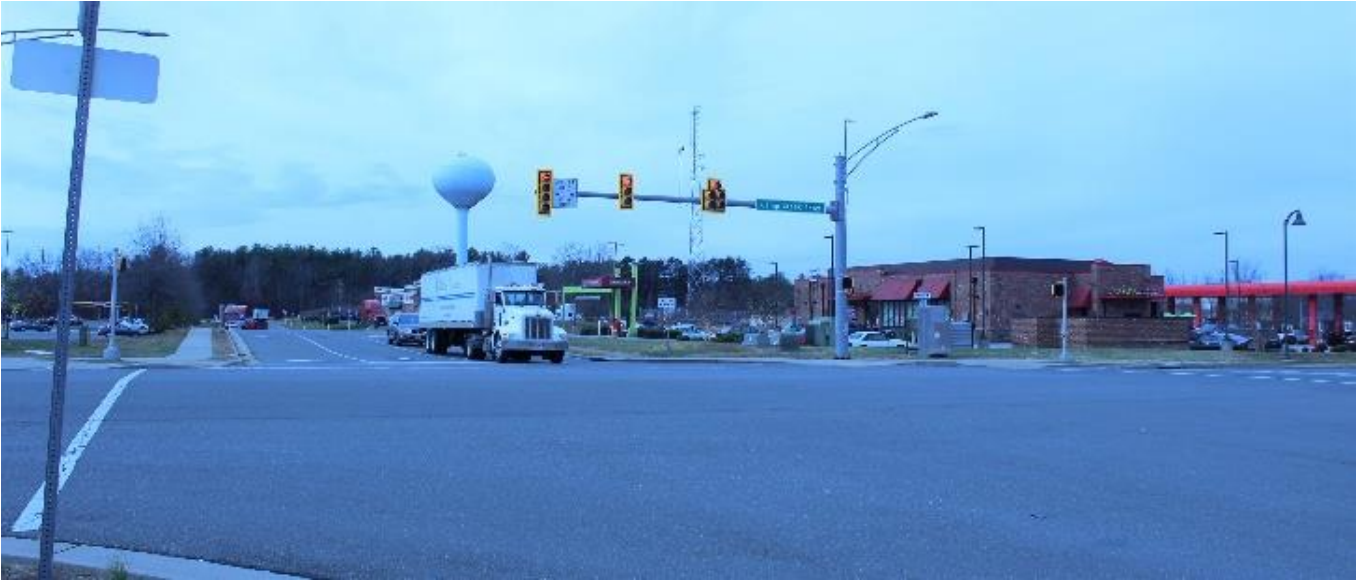
The only pedestrian facility in the study area is present along Camp Creek Parkway from the intersection with US 15 to Market Street. This connects the retail and commercial spaces in the four quadrants of the intersection. In addition, there is significant truck traffic along this section predominantly attributable to deliveries serving local businesses. These conditions are shown in Figure 8.

Figure 8 Southbound Approach on Market Street at Camp Creek Parkway (Intersection #8)

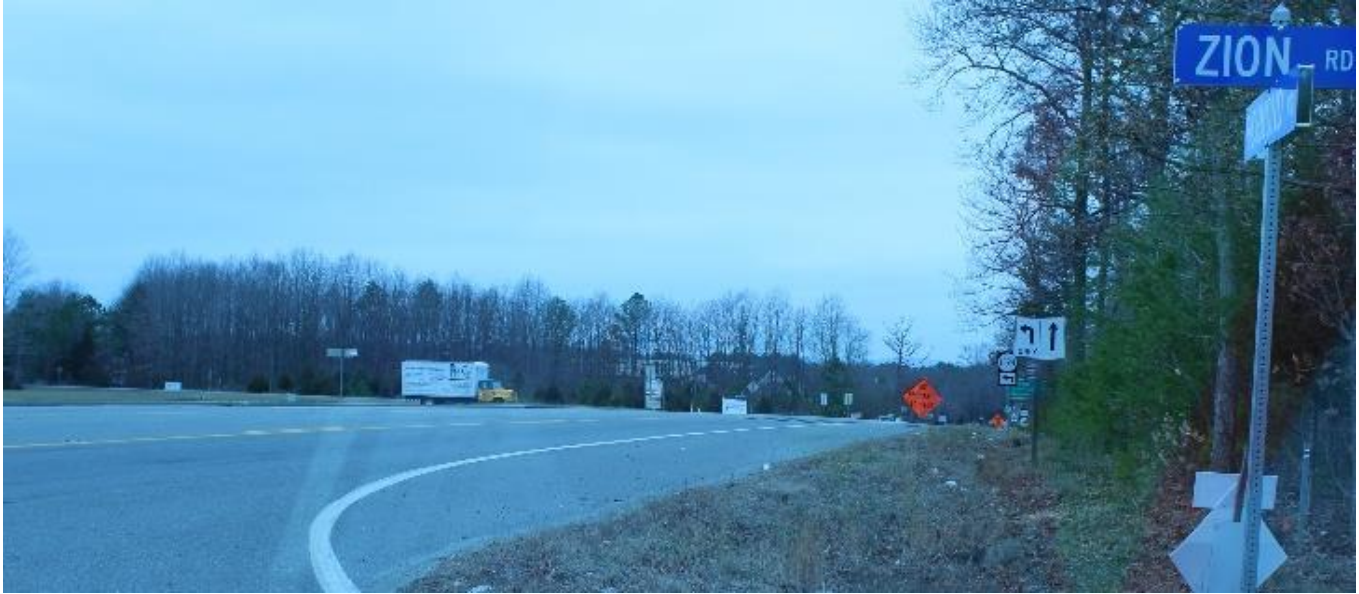
lane, undivided facility with speeds 55 MPH west of Better Living Drive and 45 MPH east of this intersection. The existing terrain has rolling hills with trees/vegetation adjacent to the roadway. Closely spaced driveways, primarily for industrial and commercial spaces, are located along this segment. This case is demonstrated at the intersection of Zion Road and US 250, as shown in Figure 9 below.

Figure 9 Zion Road looking west along US 250 towards Better Living Drive

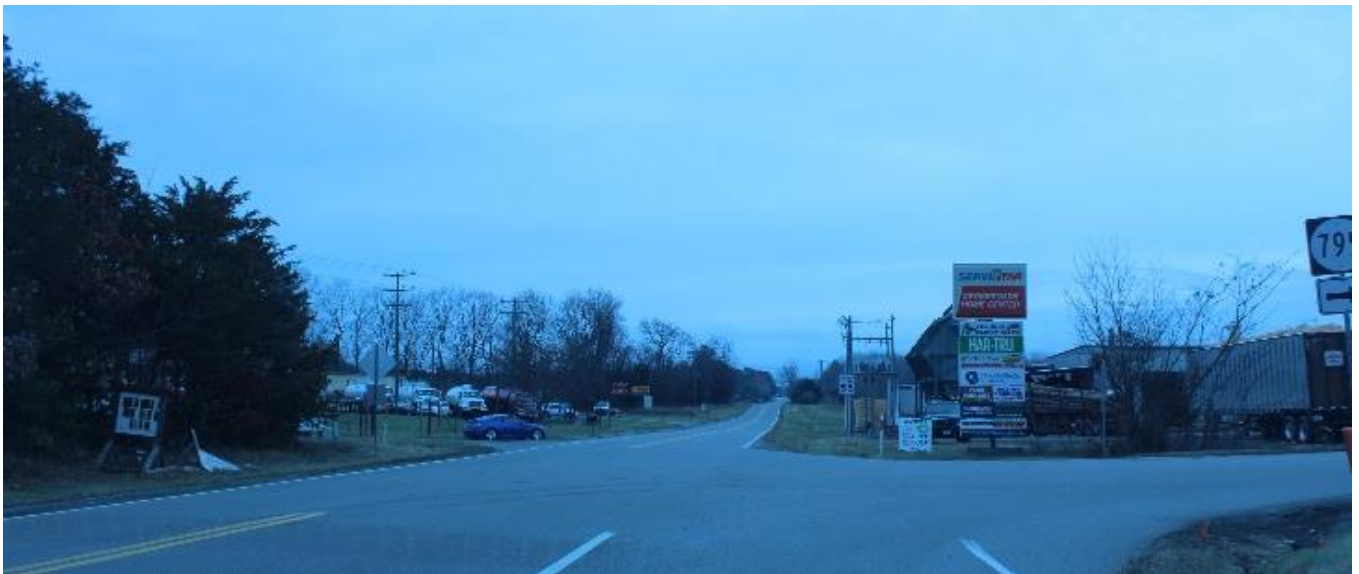
MPH at Zion Park Road. This point is also where land use type also transitions, as shown in Figure 10. The terrain tends to flatten out compared to other sections in this study area. These conditions produce an environment where vehicles are able to move quickly throughout this section without stopping.

Figure 10 Eastbound US 250 at Zion Park Road

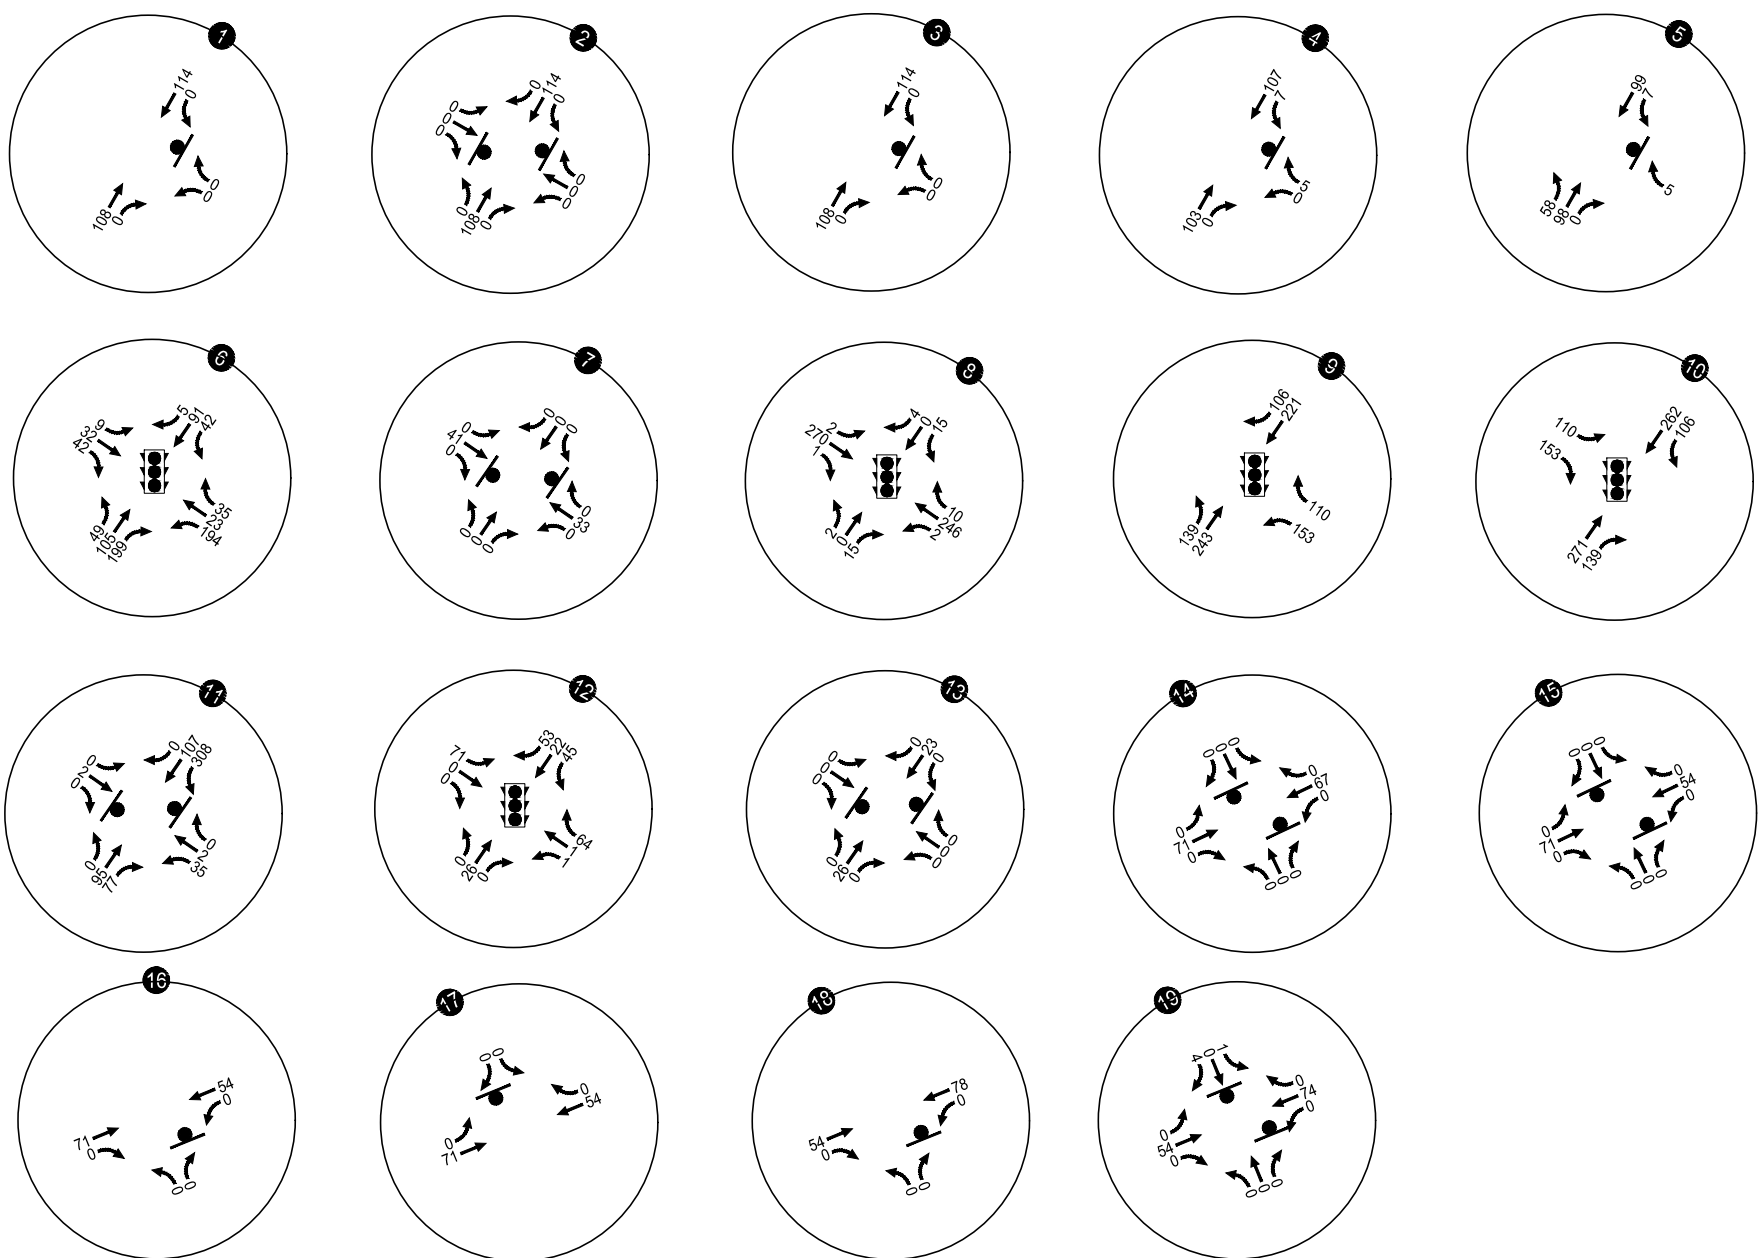
Figure
 24

In-Process Development Generated Trips
 Saturday Midday Peak Hour
 Zion Crossroads, VA

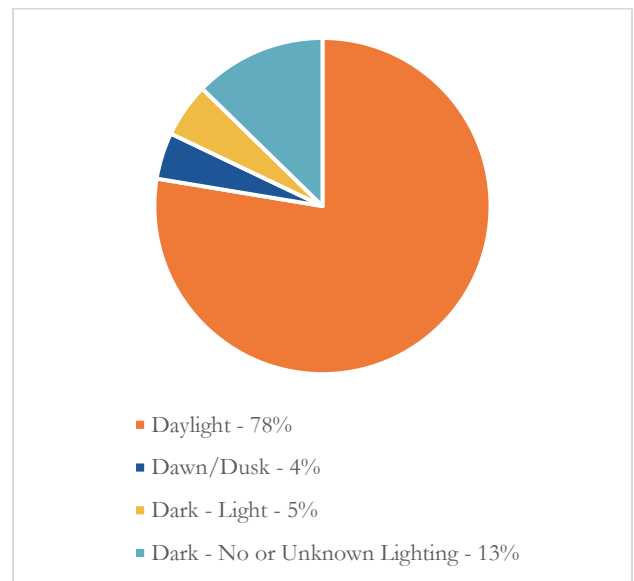
Figure 29 Percent of Reported Crashes by Lighting, January 2014 – December 2018.

- The majority of crashes (78%) occurred under daylight conditions.
- Of the 24 crashes that occurred in dark conditions, 71% of those occurred in unlit or unknown lighting conditions.

Figure 29 displays the study corridor crash count by reported lighting condition.

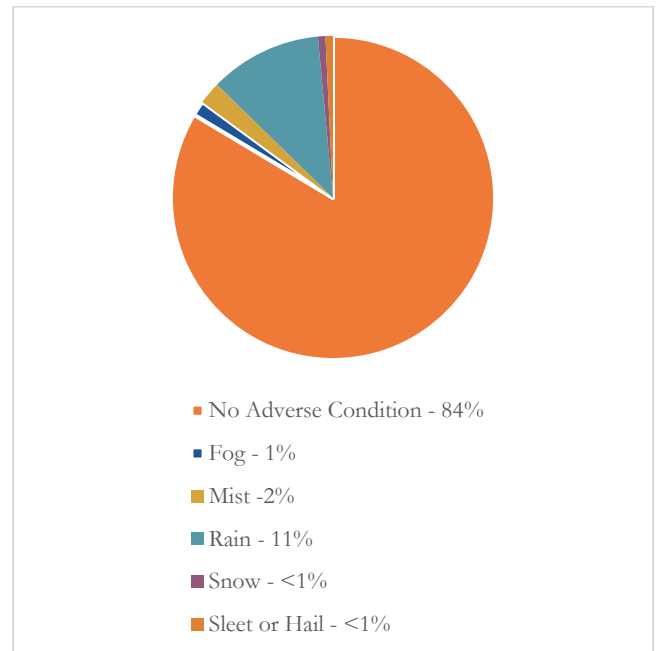
- The majority of crashes (84%) occurred under no adverse or dry conditions.
- Rain accounted for 15 of the total crashes (11%).

Figure 31 Crashes by Reported Weather Condition, January 2014 – December 2019.

Figure 31 displays the study corridor crash count by reported weather condition.

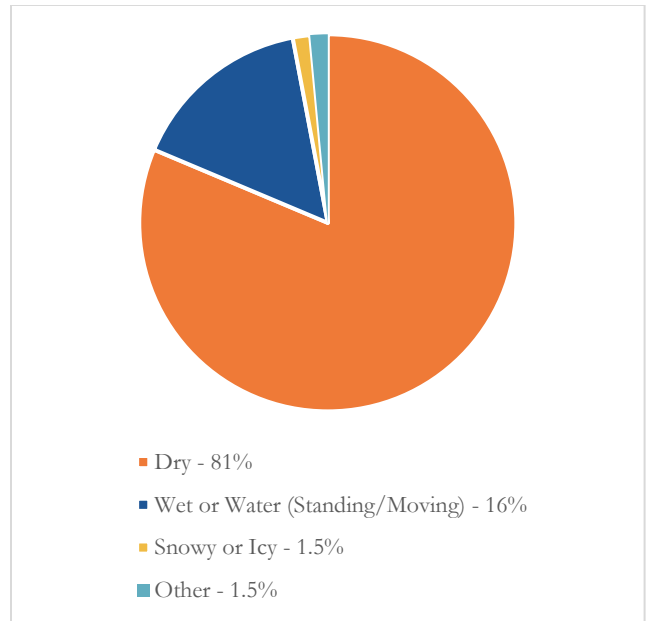
- The majority of crashes (81%) occurred while the roadway condition was reported to be dry.
- Snowy, icy, or wet roadway conditions accounted for 17.5% of the total crashes on this corridor.

Figure 33 Crashes by Roadway Condition, January 2014 - December 2018

Figure 33 displays the study corridor crash count by the reported roadway condition as an alternative way to describe the weather condition present at the time of the crash.

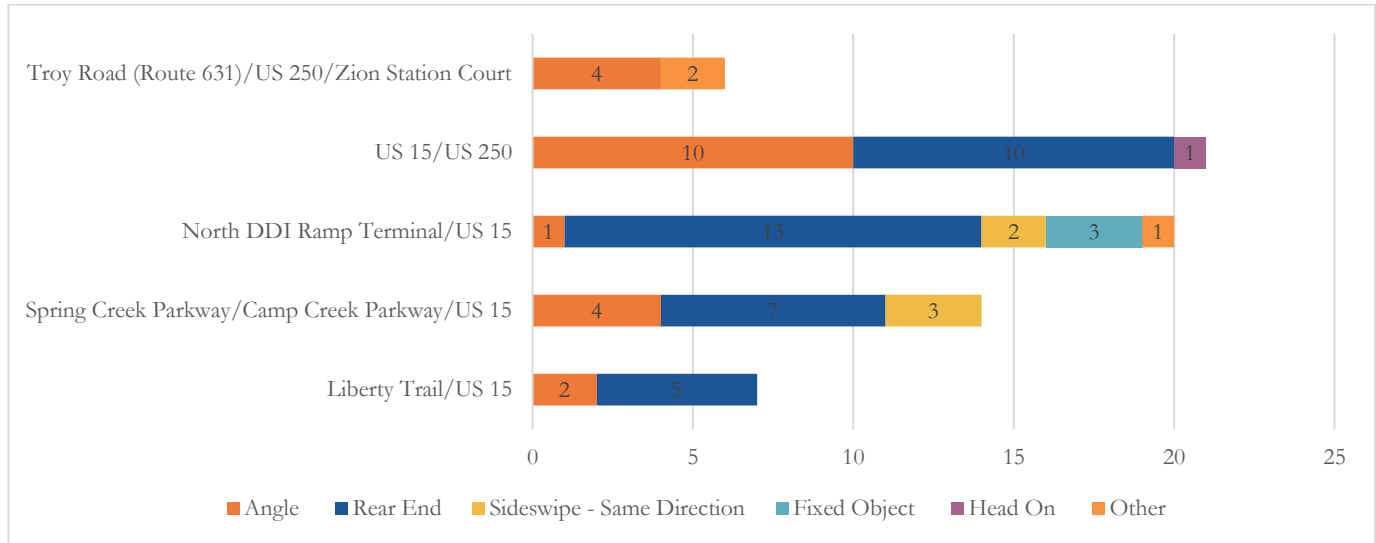
Figure 38 Crash Type by Intersection, January 2014 to December 2018

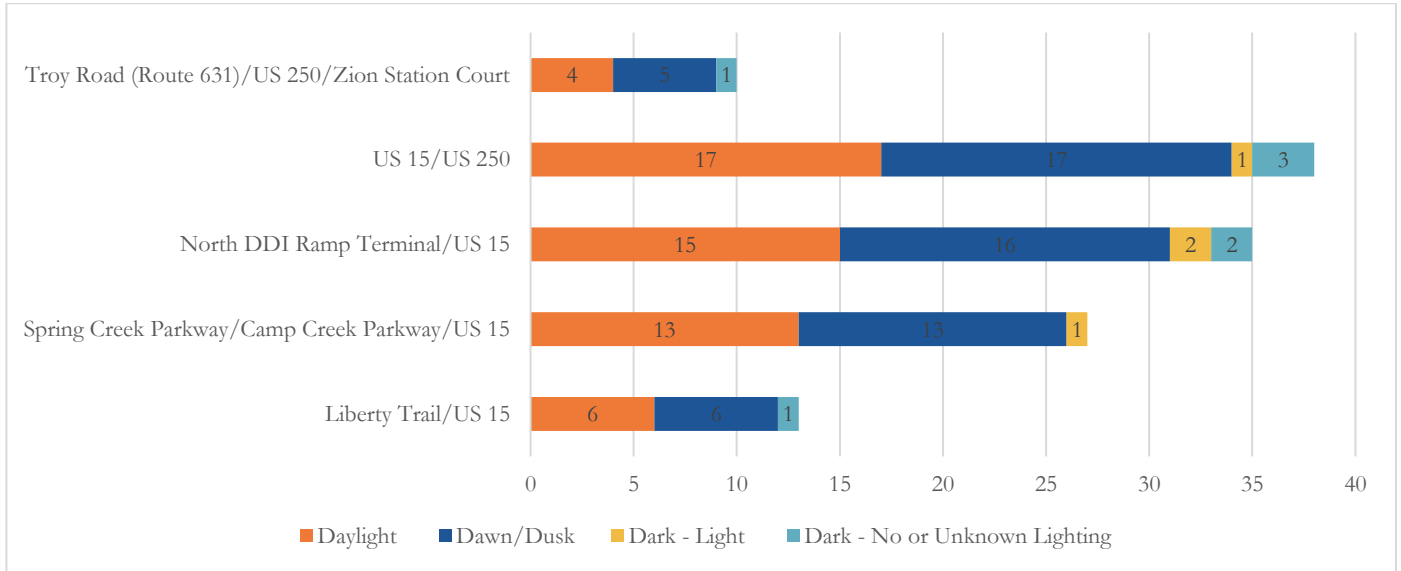
Figure 39 Reported Crashes by Lighting Condition, January 2014 to December 2018

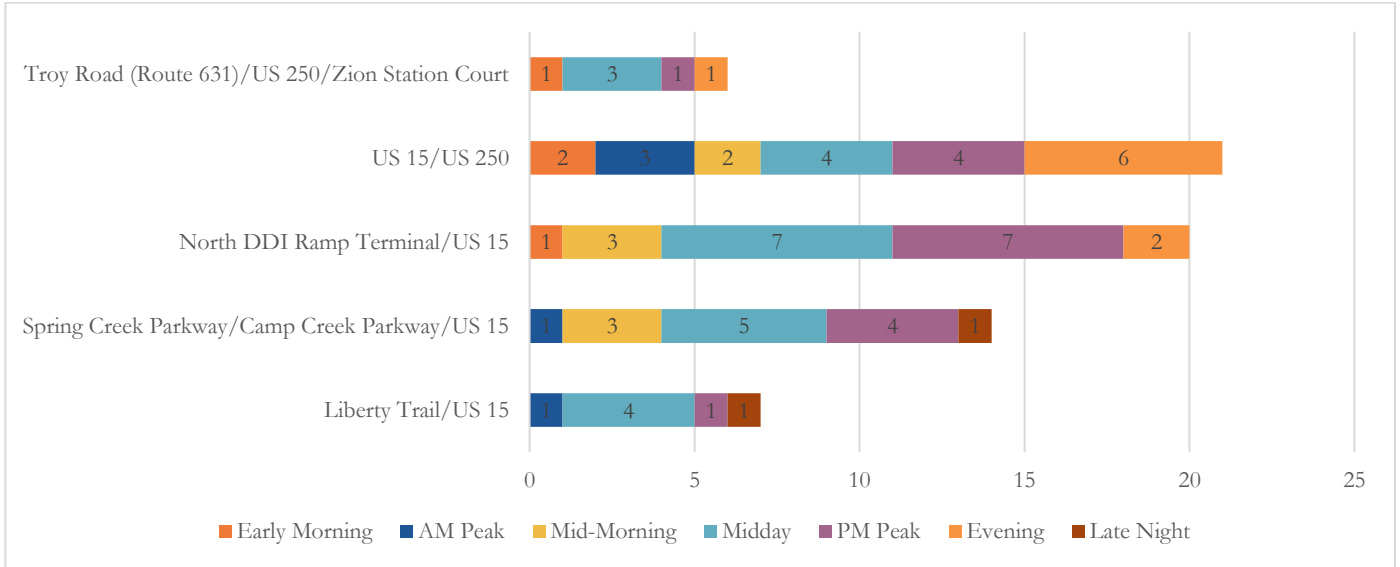
Figure 40 Reported Crashes by Time of Day, January 2014 to December 2018

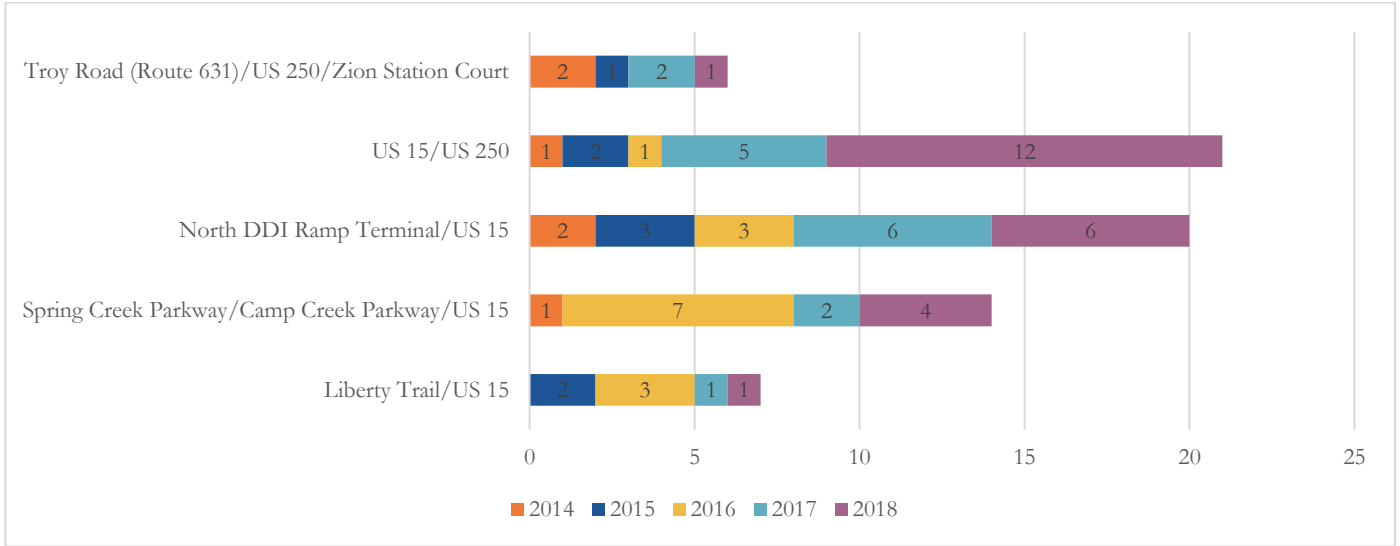
Figure 41 Reported Crashes by Year, January 2014 to December 2018
